Field Report

Project: Jackson County Recreation Center - Aquatics

Date: 12/07/2023

Field Report #: E1

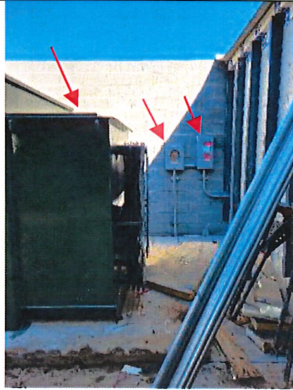
Photo 1: Service transformer, meter box, and accessible service disconnect – Mech Yard M.

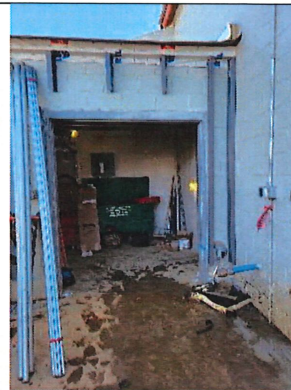
Photo 2: Electrical Room 190 exterior door.

1. Provide temporary protection for all installed electrical equipment (currently not energized) as per specs section 262416, part. 1.10 (A), specs section 017300 part 3.5 (C), 3.10 (A) and (C). Electrical Rooms 190 and 169 currently have no doors. Provide temporary doors, temporary plastic covering for equipment, and temporary heating for electrical equipment. See photos 2, 3, 4, & 5.

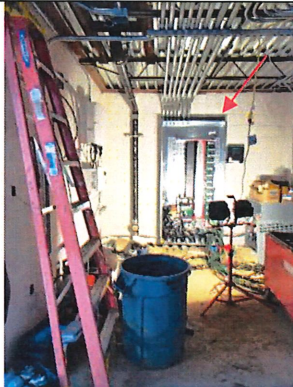
Photo 3: Panel HMDP – Electrical Room 190.

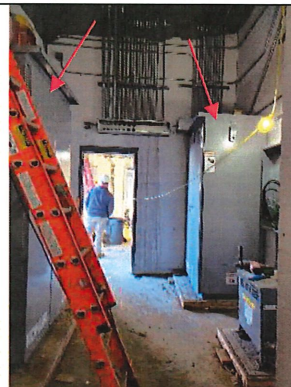
Photo 4: ATS-OS and ATS-E – Electrical Room 169.

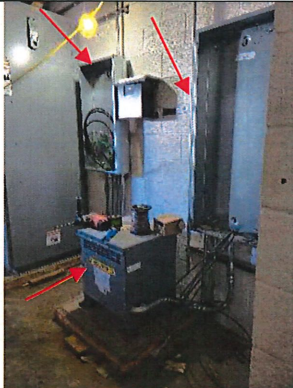
Photo 5: Panel HE tub, Xfmr XE, and Panel LE tub – Electrical Room 169.

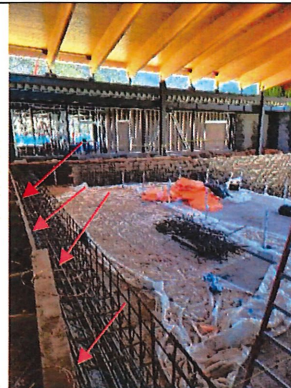
Photo 6: One end of a bare copper conductor #8 AWG ready for equipotential bonding to the pool perimeter surface structural reinforcing steel bar – southeast of Competition

Pool Deck 181. Each red arrow represents a bonding conductor.

2. Provide equipotential bonding between the Competition pool shell and pool perimeter surfaces as per 2020 NEC and drawing no. AQ603, detail 9. See photos 6 & 7.

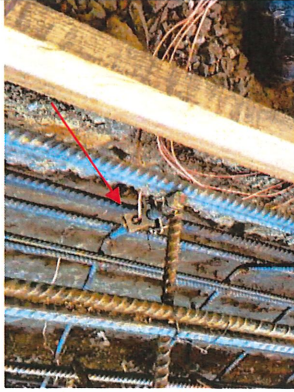
Photo 7: One end of a bare copper conductor #8 AWG bonded to Competition Pool shell (wall) reinforcing steel bar with a mechanical clamp/connector.

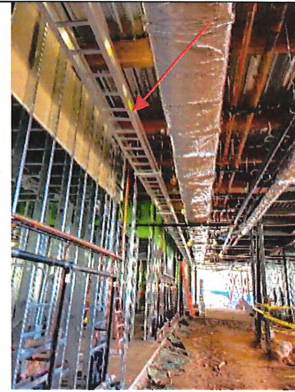
Photo 8: Telecom cable tray at ceiling space – Wet Corridor 180.

4. Telecom cable tray at ceiling space of Wet Corridor 180 with gypsum board ceiling will require ceiling access panels to allow maintenance of all telecom cables. Coordinate with the Architect/Engineer to make sure that accessibility is provided. See photo 8.
